**Project name:**  
Competence for Building a Safer Future

# Memo

**Subject:** Assessment of Safety Case for the *Commercial Building* Rev A

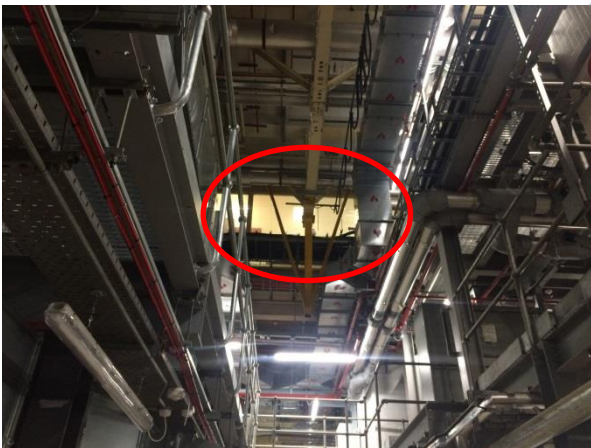
Contained within the basement of the *Commercial Building* is an extensive monitoring station that assesses the heating, ventilation and power of the building. All communication infra-structure is principally monitored from the plant room on the 25<sup>th</sup> level, but is also overseen from other smaller hubs throughout the building.

*Multi-level plant room within the basement, with monitoring station circled*

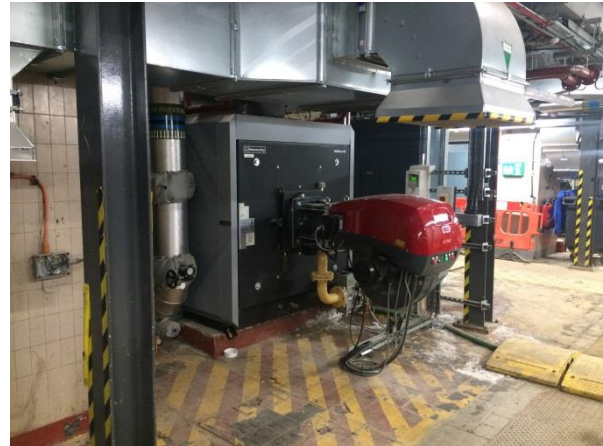
*Replacement boiler plant installed in 2017*

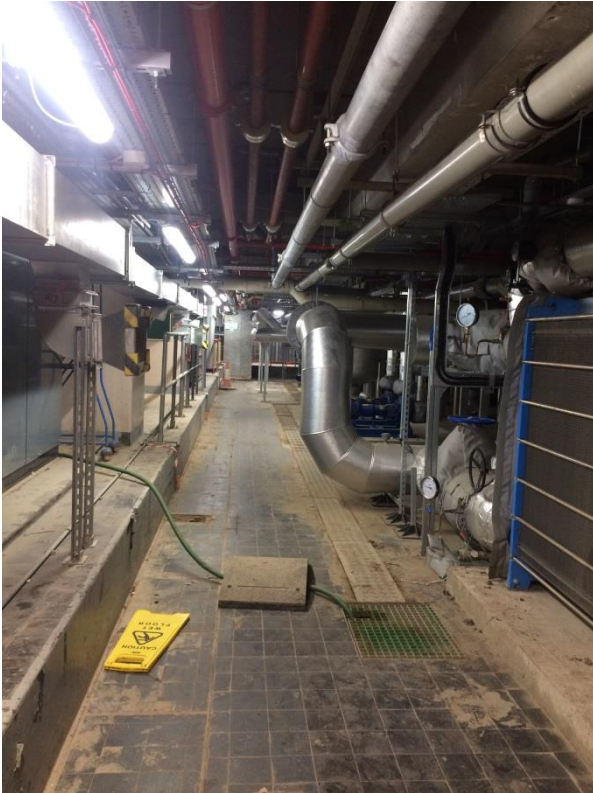
*Plant rooms contain asbestos both in the containment lining and fabric of the structure*

Similarly the decommissioned plant that resides within the building does contain hazardous material such as asbestos and lead, requiring close monitoring with regards to exposure of it to the *Commercial Building's* occupants until such a time as it is eventually removed.
